CATALYST LOADING: A CRITICAL VARIABLE

Dan Torchia and Gavin Mcleod, Chevron Lummus Global, USA, and Paul Cannatella and Greg Scott, Valero, USA, analyse the impact of proper catalyst loading on hydrocracker performance.

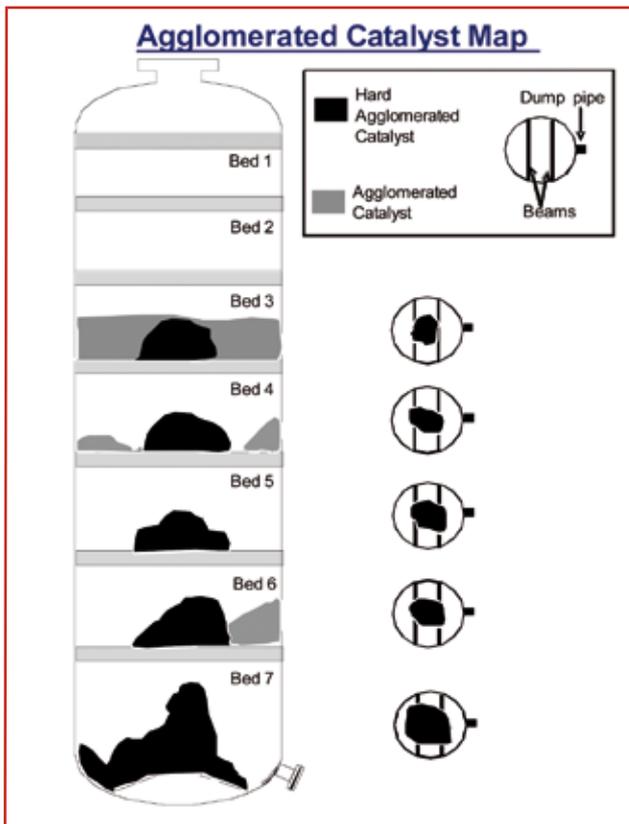
Figure 1. Agglomerated catalyst map.

CLG kept detailed records in the form of video, digital photos, and written documentation throughout the reactor turnaround. The catalyst unloading contractors were required to keep very detailed records of the condition of the reactors throughout the entire unloading process to determine the exact cause of the apparent channeling and maldistribution witnessed during Run 2. Diagrams were made at the end of each shift by the unloading contractors in conjunction with CLG personnel. After careful examination of these records it was determined that the primary cause of the problems in Run 2 was inconsistent loaded densities throughout most of the reactor; predominantly in Beds 3 and 4, where the highest radials were observed during Run 2. This was concluded based on inconsistent catalyst conditions observed while unloading. These inconsistent densities were attributed to improper dense loading, as illustrated in Figure 1.

To prevent a recurrence of Run 2 problems, strict criteria were set for the cleaning, inspection and reload of the reactors. Detailed checklists were developed specific to each bed of both reactors. After unloading was complete, the

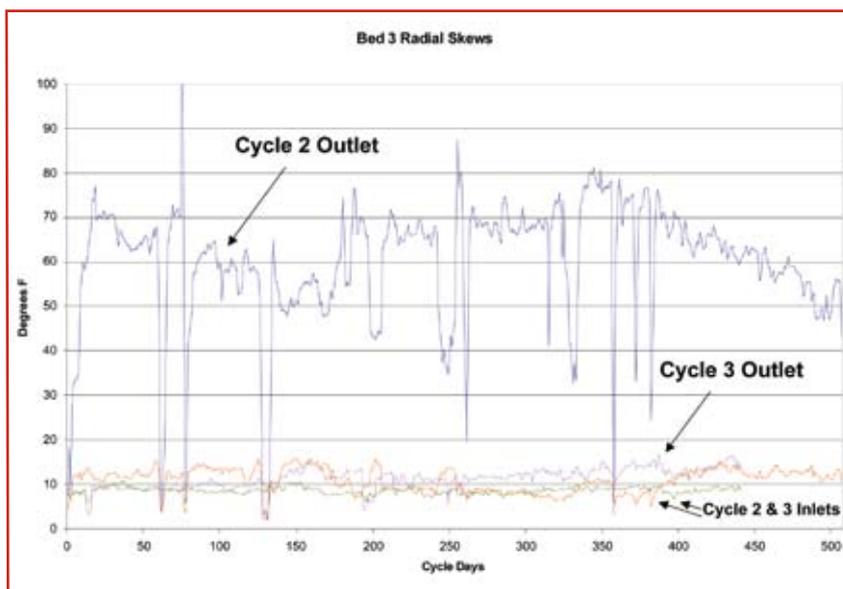
Figure 2. Comparison of Cycles 2 and 3.

Startup procedures were reviewed and modified to help ensure proper catalyst wetting and sulfiding. Detailed records of all aspects of the startup were kept for review and troubleshooting in the event of unexpected occurrences. The startup proceeded smoothly and the unit was brought online without incident. Unit data at startup showed significant improvement in reactor performance. Catalyst bed thermocouples showed even distribution throughout the beds with no signs of channelling, as illustrated in Figure 2, which compares the two cycles.
